Chelmsford - St John's Hospital Conservation Area

(former Chelmsford Union
Workhouse, Wood Street,
Chelmsford)

Status:
Adopted guidance

October 2003

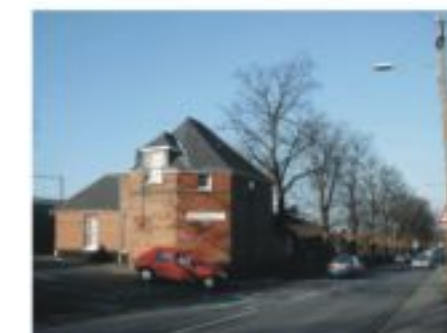
6. View down Wood Street - hospital buildings, wall and trees form strong edge to street and add character despite heavy traffic on road

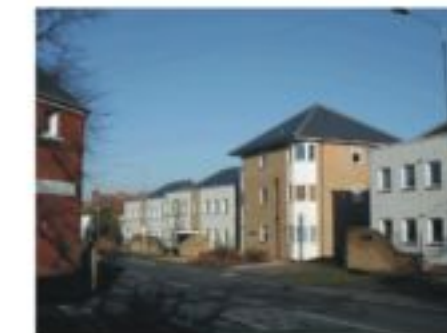
7. New development opposite the hospital. Walling and tower designed to relate to St. John's.

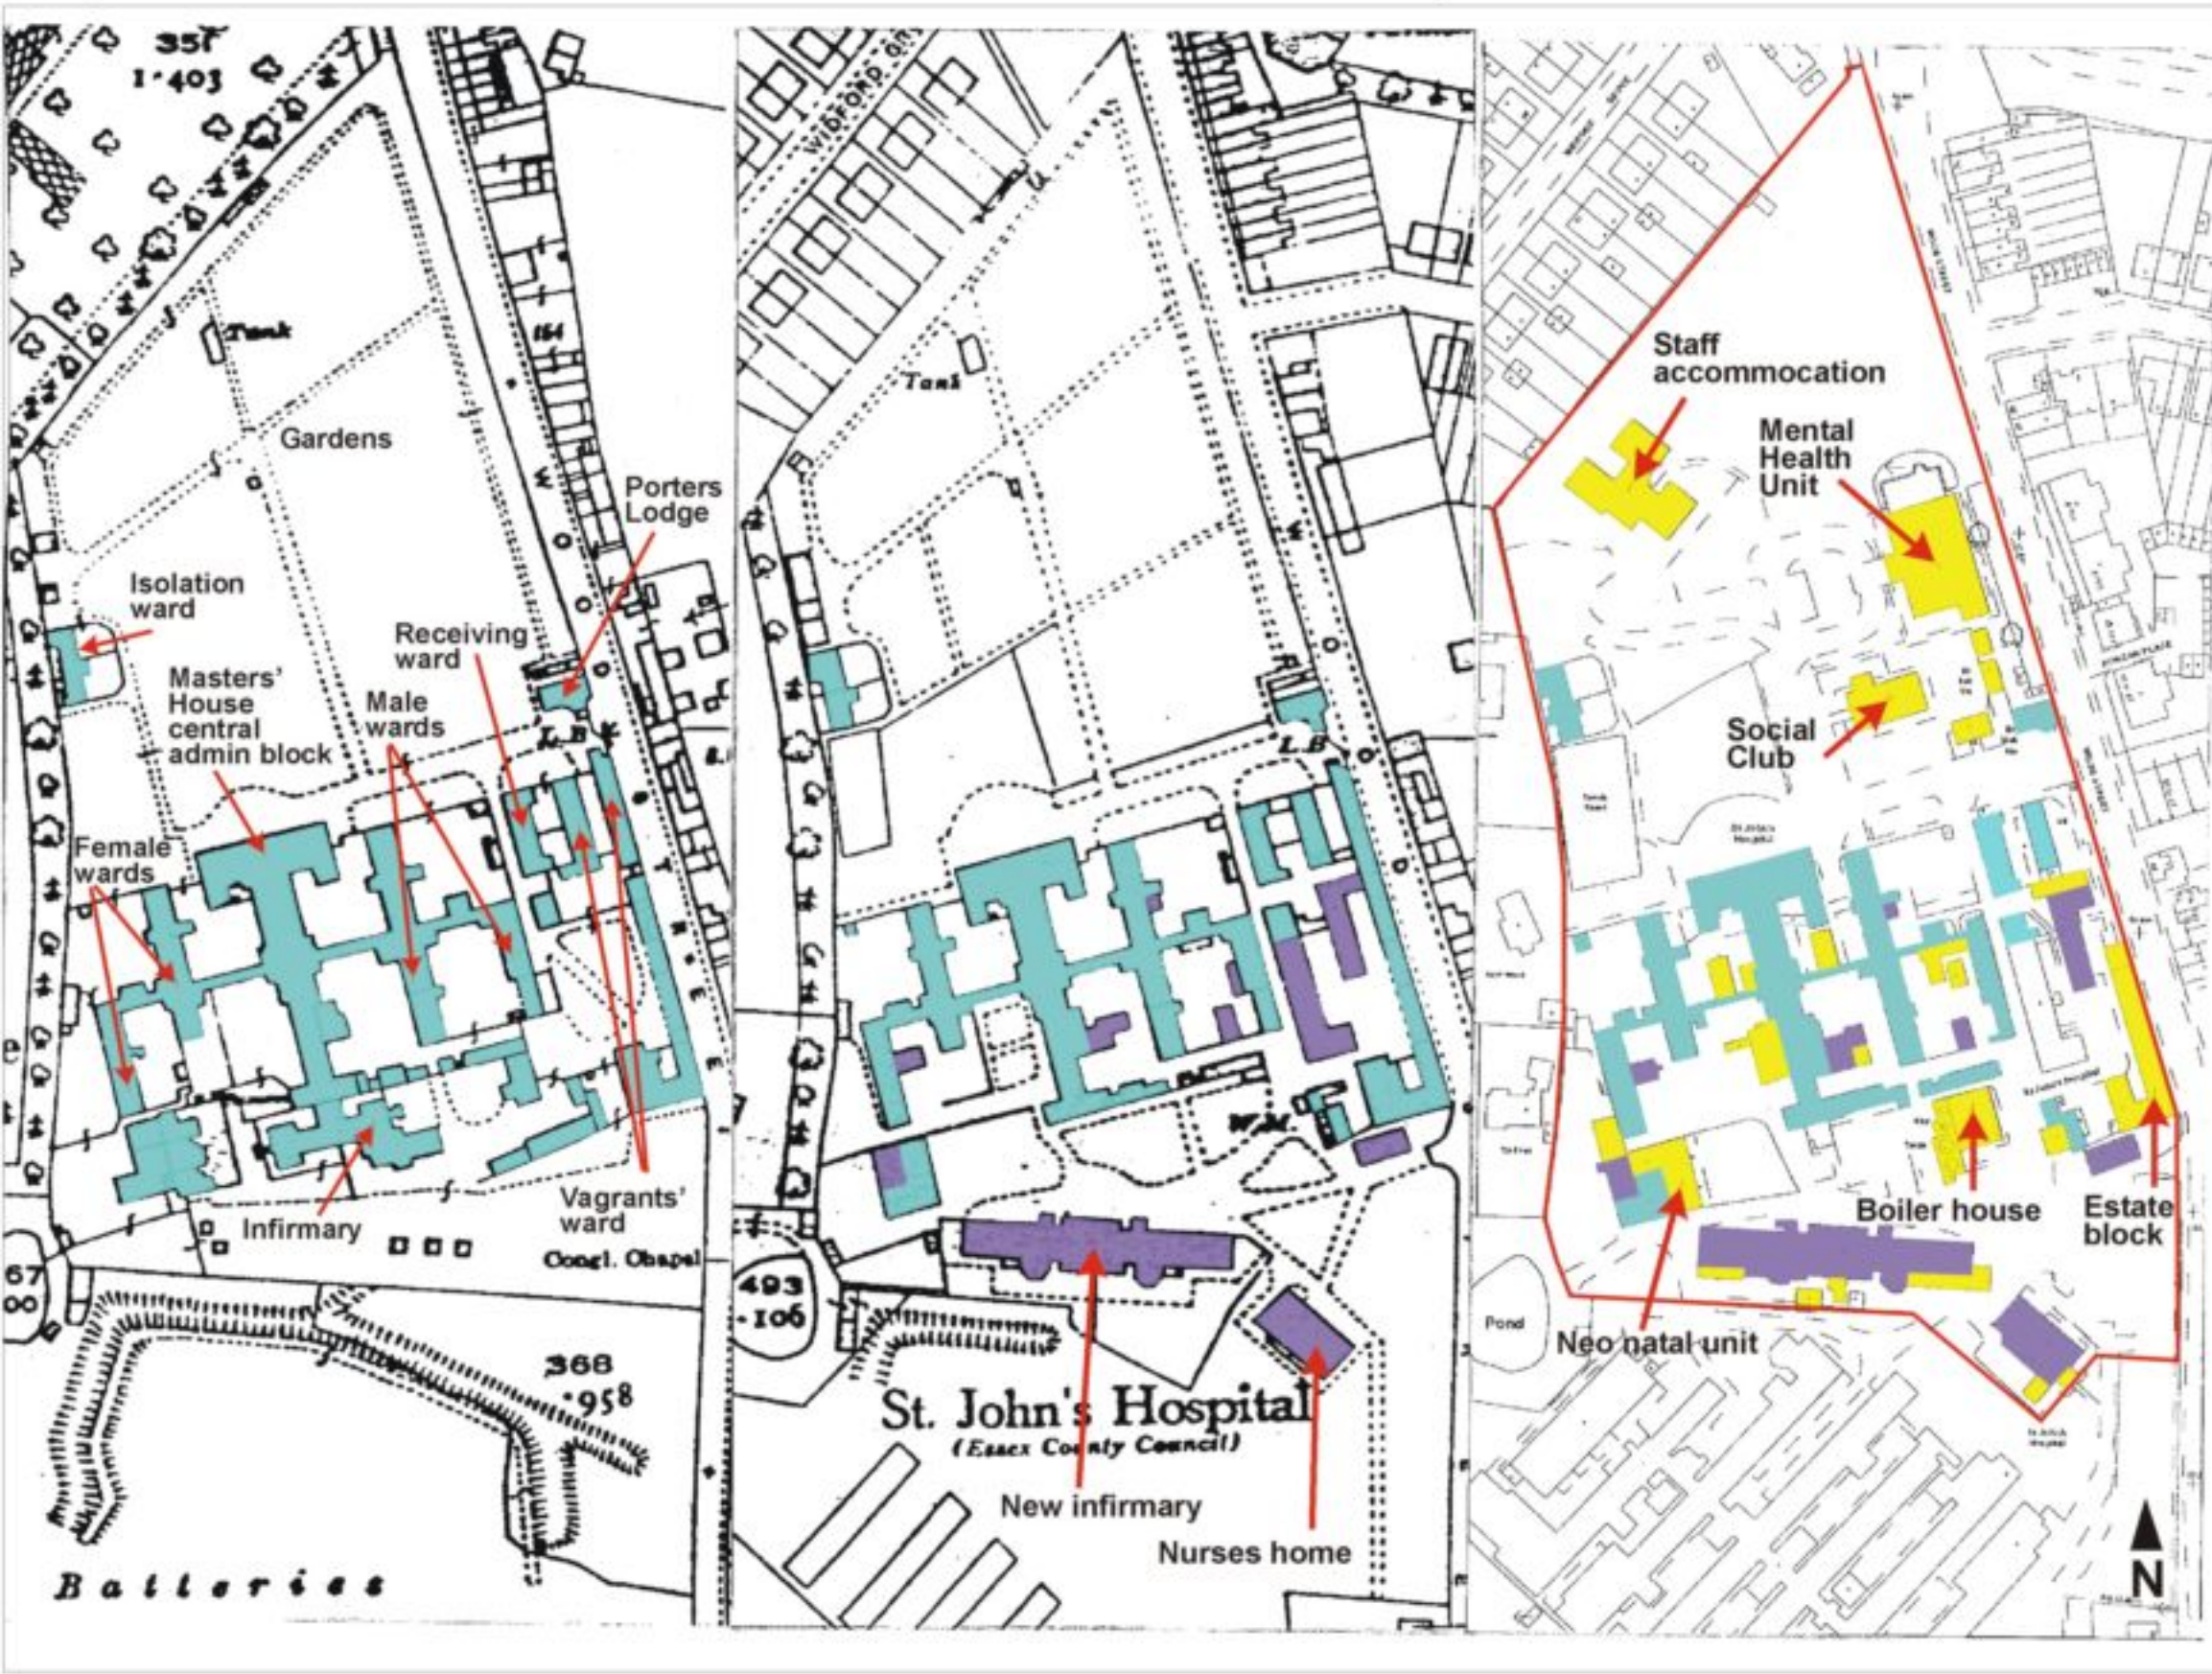
Progression from Chelmsford Union Workhouse to St John's Hospital

1921 - Workhouse

1947 - Hospital

2003 - Today

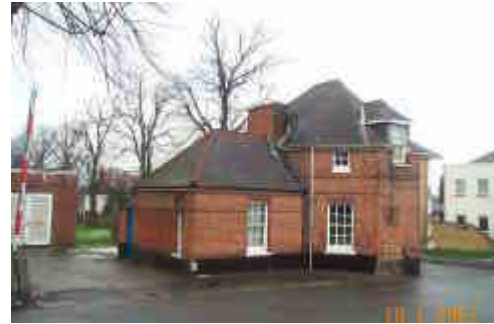
A. Porter's Lodge – Located immediately north of site access and comprising a two storey range to Wood Street and a single storey range on its western side. Road elevation is blind, southern end is polygonal. Original doorway in southern elevation now blocked. Hipped slated roof and red brick, horned sash windows. Building has low eaves with upper floor lit by hipped dormers at either end. This attractive building defined the site access and creates visual interest along Wood Street.

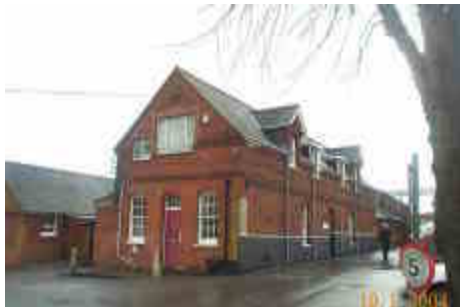
B. Female vagrant's block – One storey high and four bays long located close to the original access off Wood Street, in red brick with a slated roof. Moulded bricks used at verge. Entered through a door in its northern flank, individual cells lit by windows along its length. Relatively unspectacular architecture. Limited townscape value in helping to define northern edge of main complex, main aesthetic contribution lies in group value.

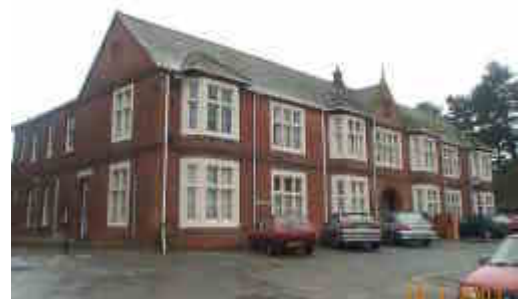
Master's House – Polite front of the workhouse. Strong formal composition, robust and well ordered. Ornamentation articulates special historical role of building.

D. Master's House / Administration block

Seven bays and of two storeys. North facing. Gabled central bay, incorporating round headed recessed entrance with four light window over and terracotta plaque in gable. Two hipped, canted bays to either side with stone window surrounds. A long range of buildings extends southwards from this block incorporating first the dining hall and chapel, then a kitchen block.

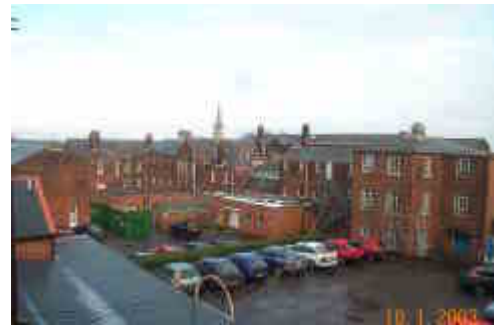
Administration/dining/chapel and kitchen range. Buildings form the core of the workhouse and constitute a strong group. Southern most range, of limited architectural merit includes a flat roofed element.

The chapel is lit by four pairs of closely set lancet windows. A gabled traverse block containing stairwells lies to the south and is surmounted by a lead bell turret. Beyond this the north/south range continues eventually abutting a three storey kitchen block that is now the only element that obviously remains from the original 1837 workhouse. A much altered three storey traverse block terminates the range

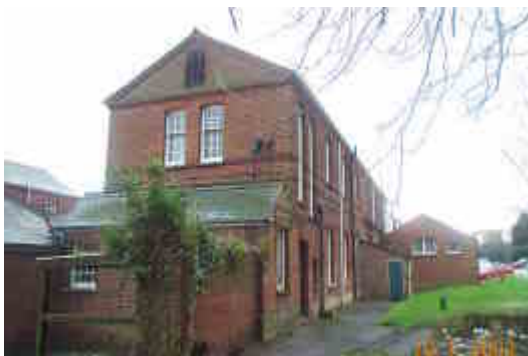
Girls pavilion block

E/F. Male and female pavilion wards - In total there are four main pavilion wards. These comprise a two storey girls block and two storey women's block to the west of the administration/chapel range, and a three storey men's block and three storey boys block to the east of the administration/chapel range. The pavilion blocks lie parallel to each other, running north-south and are linked by a central corridor. Original 6/9 sliding sash windows are present, set in deep reveals with stone cills and segmental brick arches. Sash boxes are concealed behind the outer leaf of brickwork. All are of red brick with brick plat bands, and have gabled slated roofs with red ridge tiles. A small amount of moulded brick is used as string courses and gable surrounds. Occasional full storey height but shallow gabled projections spring from the side of the pavilions, accommodating stairs and sanitary facilities. Solid chimney stacks present on gables and roofs. Wards integral to the historic function of the workhouses, demonstrating key principle of segregation.

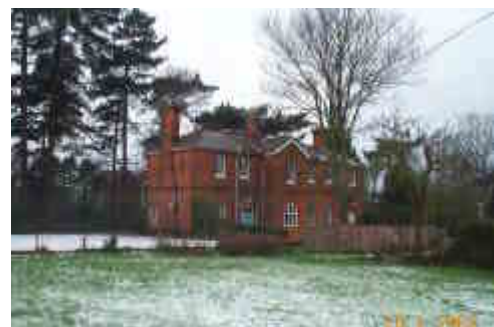
G. Infectious diseases block - Two storeys in red brick with hipped slated roof. Main building of five bays and symmetrical plan with central gabled projection at front containing an ocular vent dated 1869. Two storey addition to north. 6/6 sliding sash windows, some openings altered. Now converted into two dwellings, original exercise yards still evident on eastern side. Well proportioned, free standing structure enjoys attractive landscape setting.

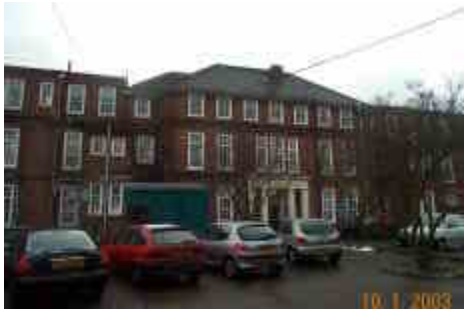
H. Infirmary – Three storeys in red-brown brick with quoins, constructed in 1926. The central block has a hipped roof clad in plain clay tiles and projects forwards incorporating a tripartite Tuscan colonnade at the main entrance in the centre of the northern elevation. Parapetted flat roofed wings lie at either side. Deep windows with 6/6 sliding sashes, lower floors have hopper over.

Numerous modern additions at rear. In use as a general maternity unit for some time. Attractive formal composition, its scale commands the space to its front. Flat roofed additions to wings unfortunate.

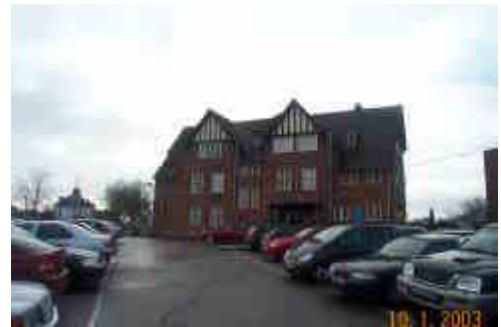
I. Nurses Home – Constructed in 1926. Two-and-a-half-storeys in red-brown brick with plain clay tiled roof and timbered gables. Canted bays with balcony over to rear. Sound building although architecturally relatively unremarkable. Building helps define space in the south of the workhouse and, like the replacement infirmary, is an important part of the evolution of the workhouse as Victorian attitudes became softened in the early 20th century

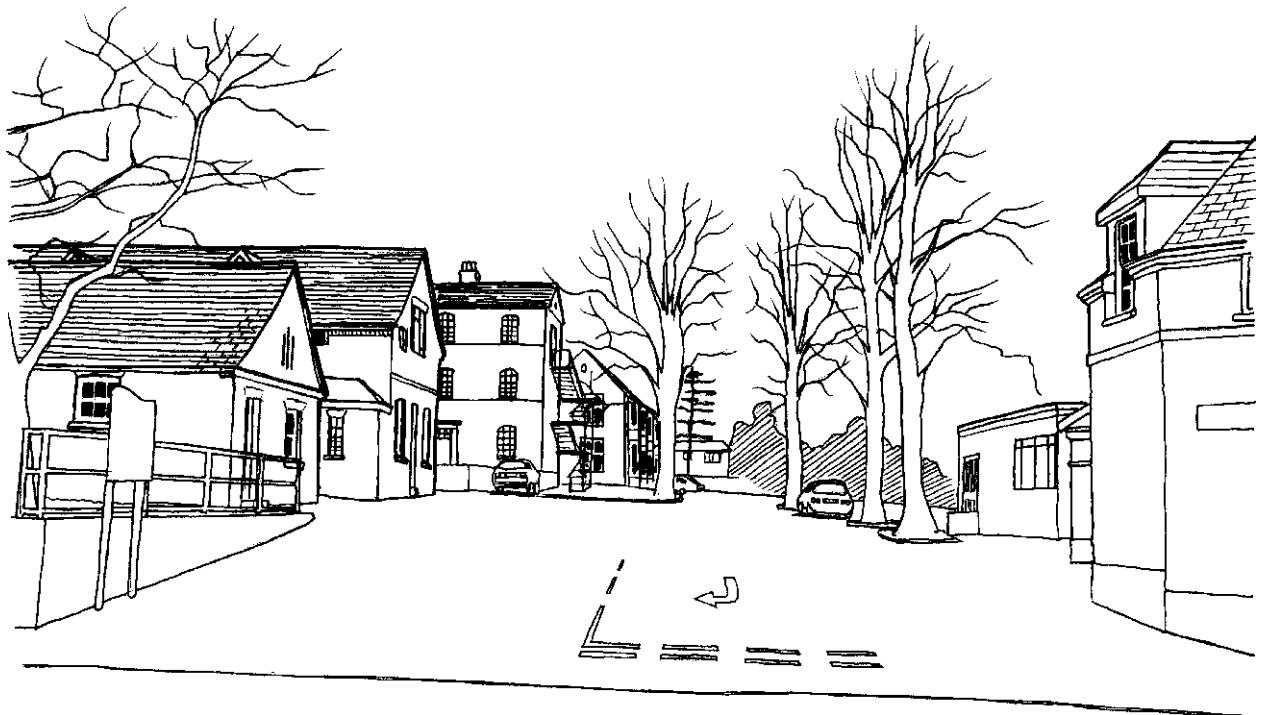
View into site from main entrance. Buildings to left form strong edge between the main grouping and the more open former gardens to the right (beyond the porter's lodge). Note – Fire escape on end of men's block and horizontal railings to left of access are notable visual distractions.

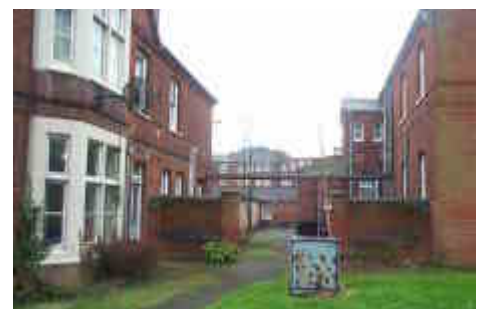
The workhouse itself is built to a high density. Mainly two and three storey buildings are arranged formally and create tight urban courtyards which would have been used as segregated airing yards for paupers. The level of enclosure that can still be experienced in these spaces gives one a good impression of life and conditions in the workhouse

View into airing yard

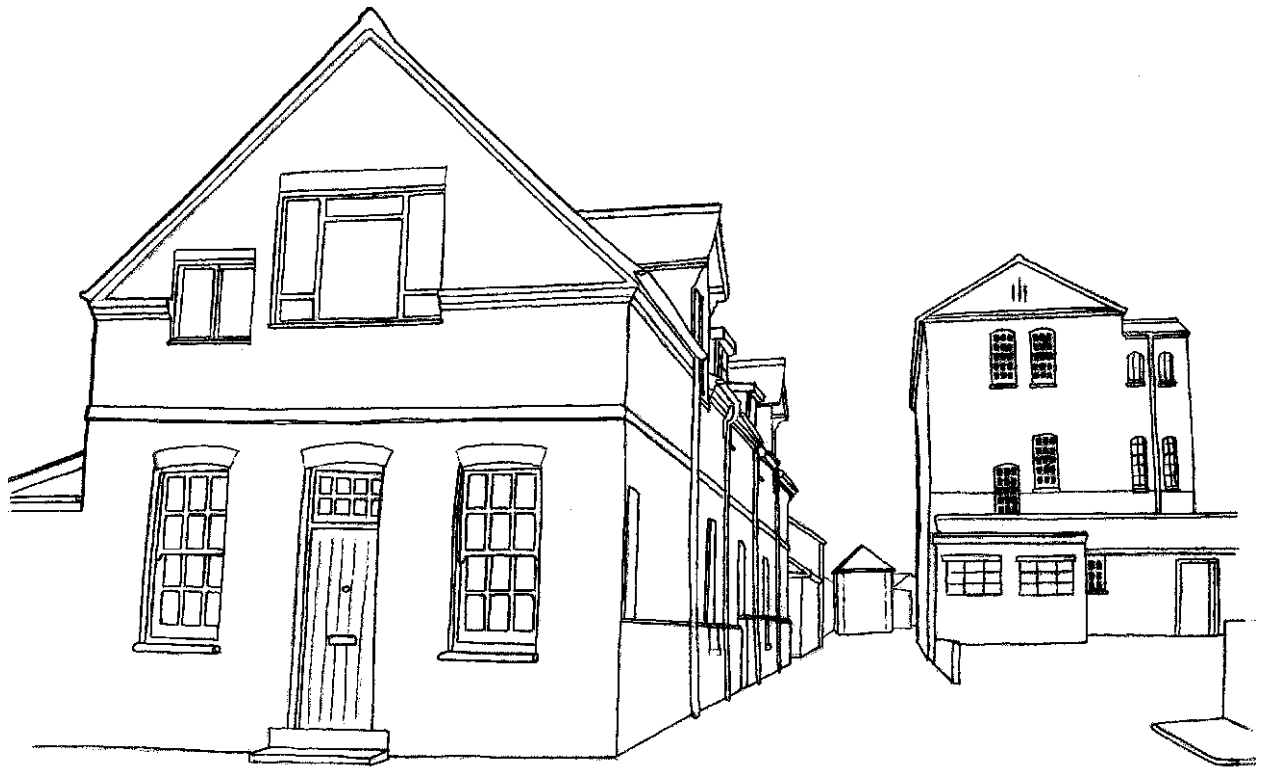
View along interior cartway, with old receiving ward to left and boy's pavilion ward to right. Buildings enclose space, and hardscaping reinforces urban character of main workhouse grouping.

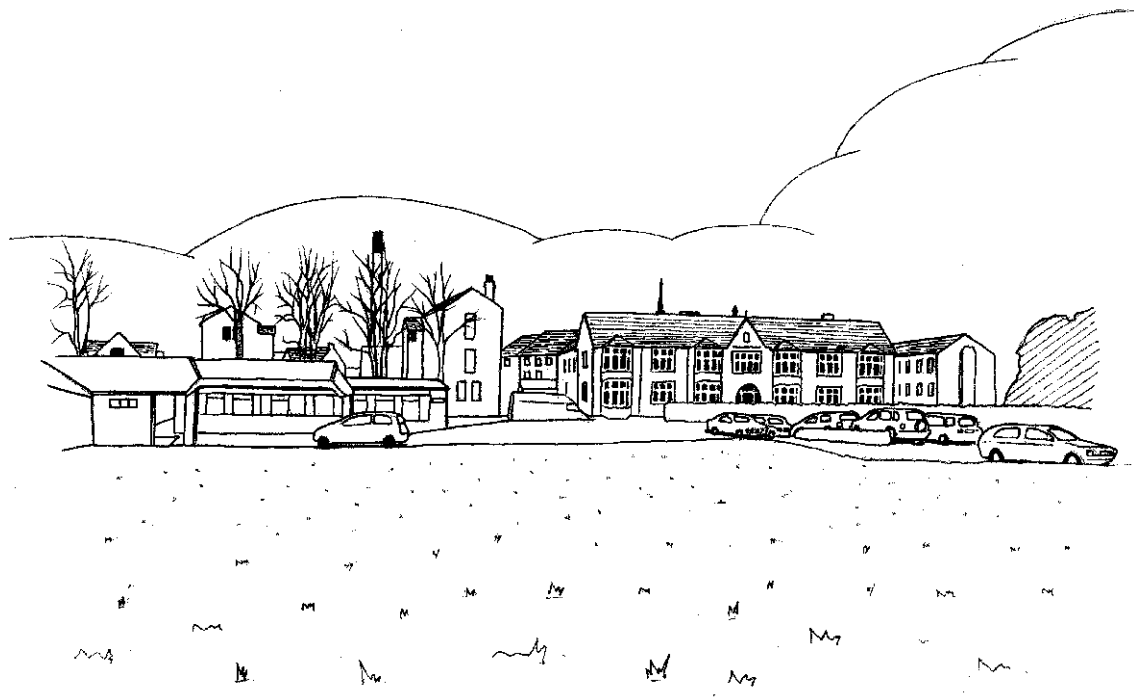
View of main grouping from bottom of hill across former workhouse gardens. Dramatic skyline created by topography and strong edge. Roofline enlivened by chimneys, cupolas, turrets and varying storey heights.

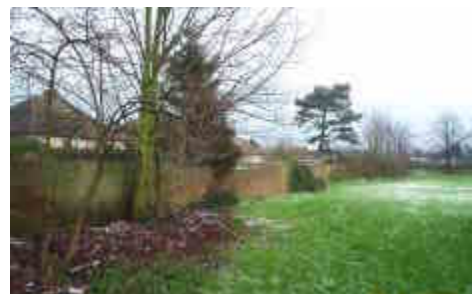
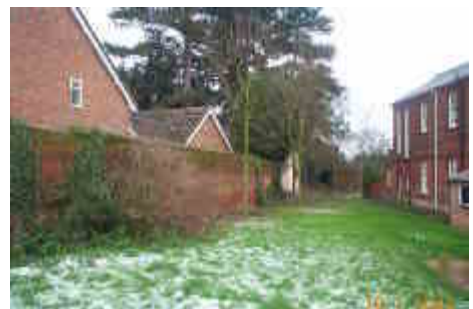
The wall at the bottom of Wood Street is approximately 2.5m high and is a strong and robust feature that contributes significantly to the feel of Wood Street, which is otherwise characterised by nondescript mixed twentieth century ribbon development and is dominated by vehicular traffic. The wall retains higher ground on the hospital side and a projecting plinth is present at the level of the ground behind. Constructed in soft red bricks, the wall incorporates uniformly spaced pilasters with sloping shoulders, plinth capping bricks are also used to provide

ornamental coping. The upper section of the wall gives way to railings. A retaining plinth wall remains with concrete coping stones, 18 inch thick brick pillars are uniformly spaced carrying simple iron railings with no decorative detailing. The railings run up the hill to a further short section of wall which terminates in the porter's lodge placed hard up against the road and forming an edge to the street. A line of preserved lime trees behind the wall and railings overhang Wood Street, forming a strong linear feature of high amenity value.

A high wall would have surrounded the workhouse to detach paupers from the surrounding community, the majority of this wall which is approximately 2-2.5m high remains intact with the notable exceptions of the southern boundary where most of the wall was removed no doubt to permit expansion of the hospital to the south, and the southern section of the Wood Street frontage where a newer wall replaces the original wall which incorporated a number of structures including cart-sheds, stables and the male vagrant's block. The wall that does remain, together with a number of mature trees around the margins of the grounds, provide good enclosure to the periphery of the former workhouse gardens enhancing and reinforcing the Wood Street frontage.

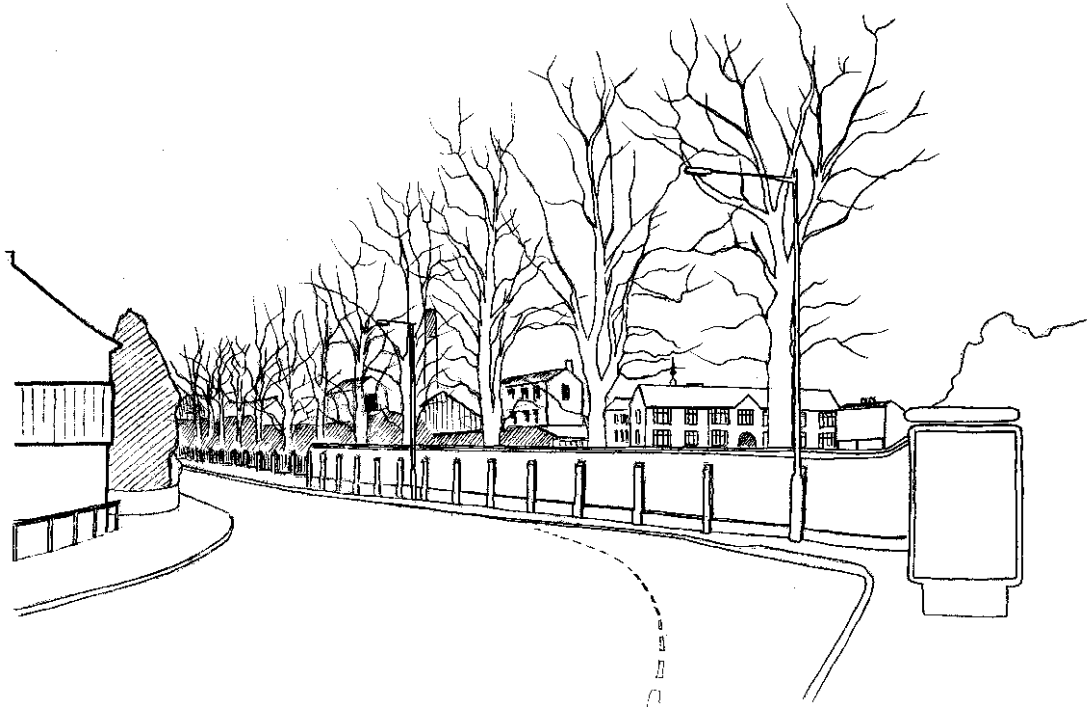
Views up and down Wood Street. Wall, wall and railings, buildings and trees within hospital grounds provide good enclosure and character to the west side of the street. Trees are the subject of a tree preservation order (Ref : 2003/43)

The upper section of wall to Wood Street, south of the site entrance has been replaced and consists first of a 2m retaining wall then a 5m high blank wall that is actually the rear of a modern flat roofed estates block on the road boundary of the hospital. These walls reflect the imagery of the old workhouse wall in the most basic sense, but lack proper detailing. The lower wall lacks robustness in comparison to the original wall, the 5m section is a fairly bland and intimidating feature in Wood Street.

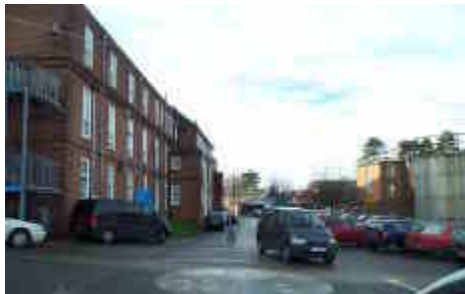
Other site features and spaces that contribute to character include a square to the south of the old workhouse complex defined by the 1926 infirmary (maternity unit), a much altered laundry block (neo-natal clinic), the southern end of the main administration block and a modern boiler house. The neo-natal clinic and maternity unit take access off the square, the latter in particular features a good formal elevation to enclose the southern side of the square. The space within the square is somewhat disrupted by ad-hoc car parking and street furniture.

View into square

- In particular clutter should be reduced within the square defined by the maternity block, neo-natal unit, southern end of the main administration range and the boiler house. Replacement of the boiler house and alteration of the traverse range at the end of the administration block should be considered to provide more sympathetic buildings that provide better enclosure and definition to the square.

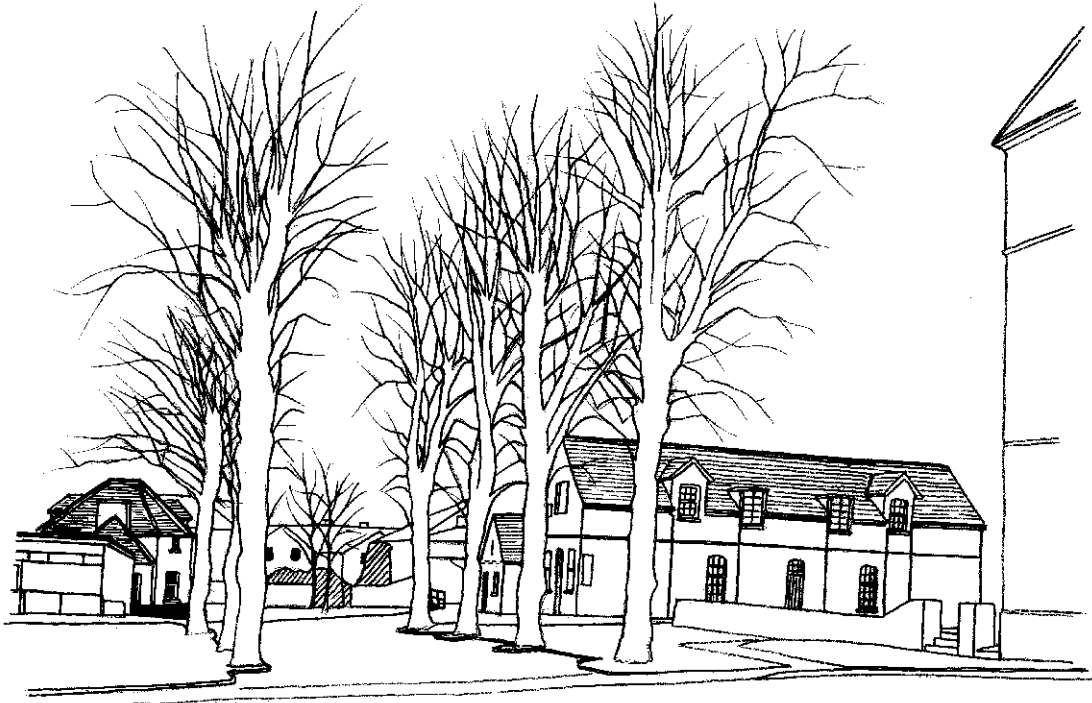
View of avenue at site entrance looking back from master's house / administration block

A short avenue of pollarded lime trees lies at the entrance beyond the porter's lodge. Whilst some trees have been lost those that remain still form an attractive

feature on the approach to the master's house / administration block and have been the subject of a tree preservation order (ref : 2003/43). The trees like the master's house, provide a welcome foil to the harshness of the workhouse buildings to the south.

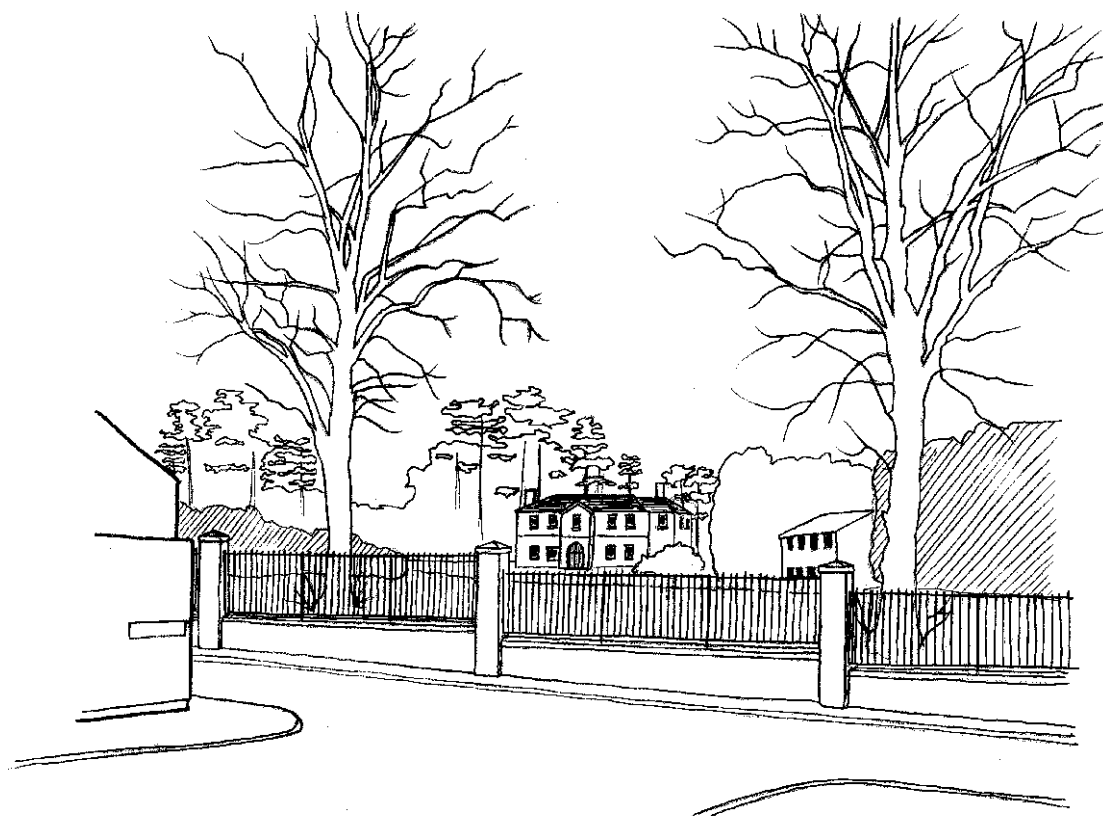
View across former workhouse gardens to old infectious diseases block. Building framed by trees in foreground, pine trees of houses in Links Drive provide a backdrop.

The former infectious diseases block lies on the western side of the former workhouse gardens. It is framed by trees in views from Bruce Grove at its junction with Wood Street. The undeveloped character of the former workhouse gardens, and impact of trees and wall/railings is evident.

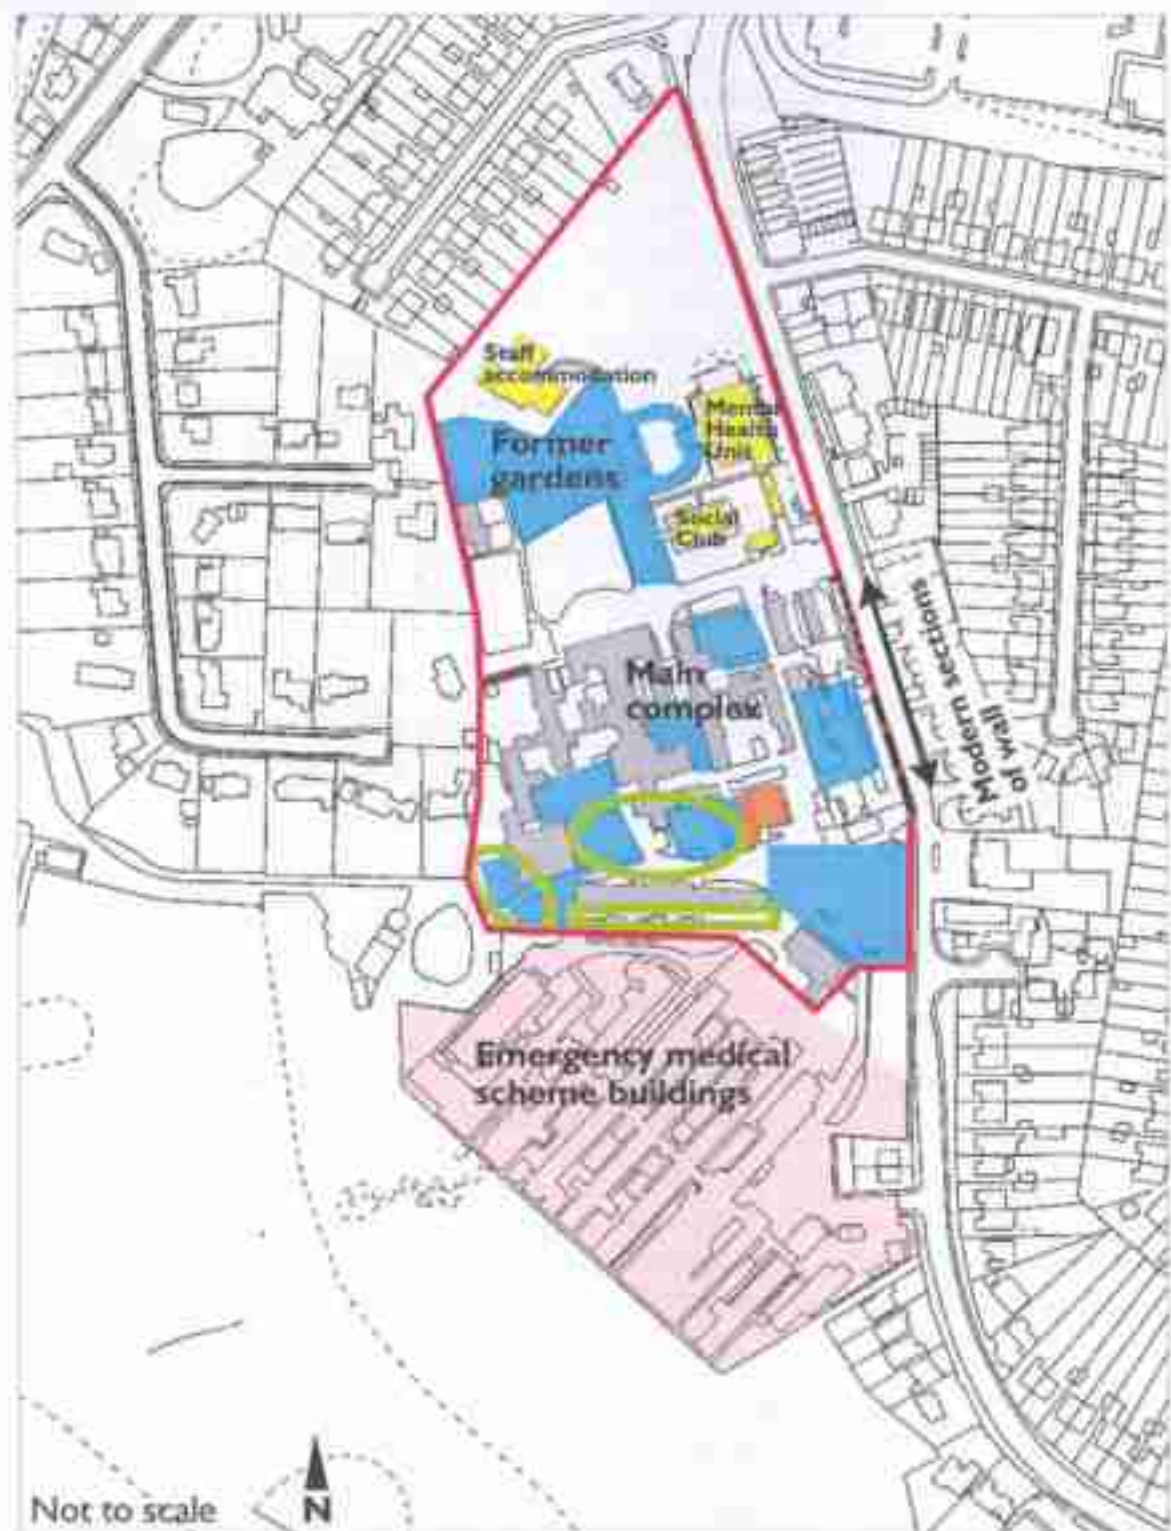
Negative features

- The detailing of the original perimeter wall is absent from that stretch of the Wood Street frontage south of the porter's lodge. The lower section of this stretch lacks robustness with the void created by the demolition of the male vagrants' block apparent from the road. The rear wall of the estates block turns its back on Wood Street, presenting a high featureless elevation to the road.
- The space in front of the nurses home lacks definition – the space leaks away and lacks enclosure on all sides other than that defined by the facade of the nurses home.
- The former emergency medical scheme buildings in the south of the site are low, sprawling structures of lightweight construction. They do not sit well with the more solid and substantial workhouse buildings within the conservation area to the north.

Compared with the strength of character that the workhouse possesses these negative features are relatively minor in significance and can be satisfactorily addressed through specific enhancement measures or as part of the future evolution of most of the site into a new residential area.
